Ironmills Park, Dalkeith: Access Route**Report by Ricky Moffat, Head of Commercial Operations****1 Purpose of Report**

Appendix 1 Ironside Farrar's report on Ironmills Steps Post Remedial Works Inspection Revision A, dated May 2015

Appendix 2 Ironmills Steps - Photos showing damage caused by landslip taken on 31 May 2016

IRONMILLS STEPS
Post Remedial Works Inspections
Revision A

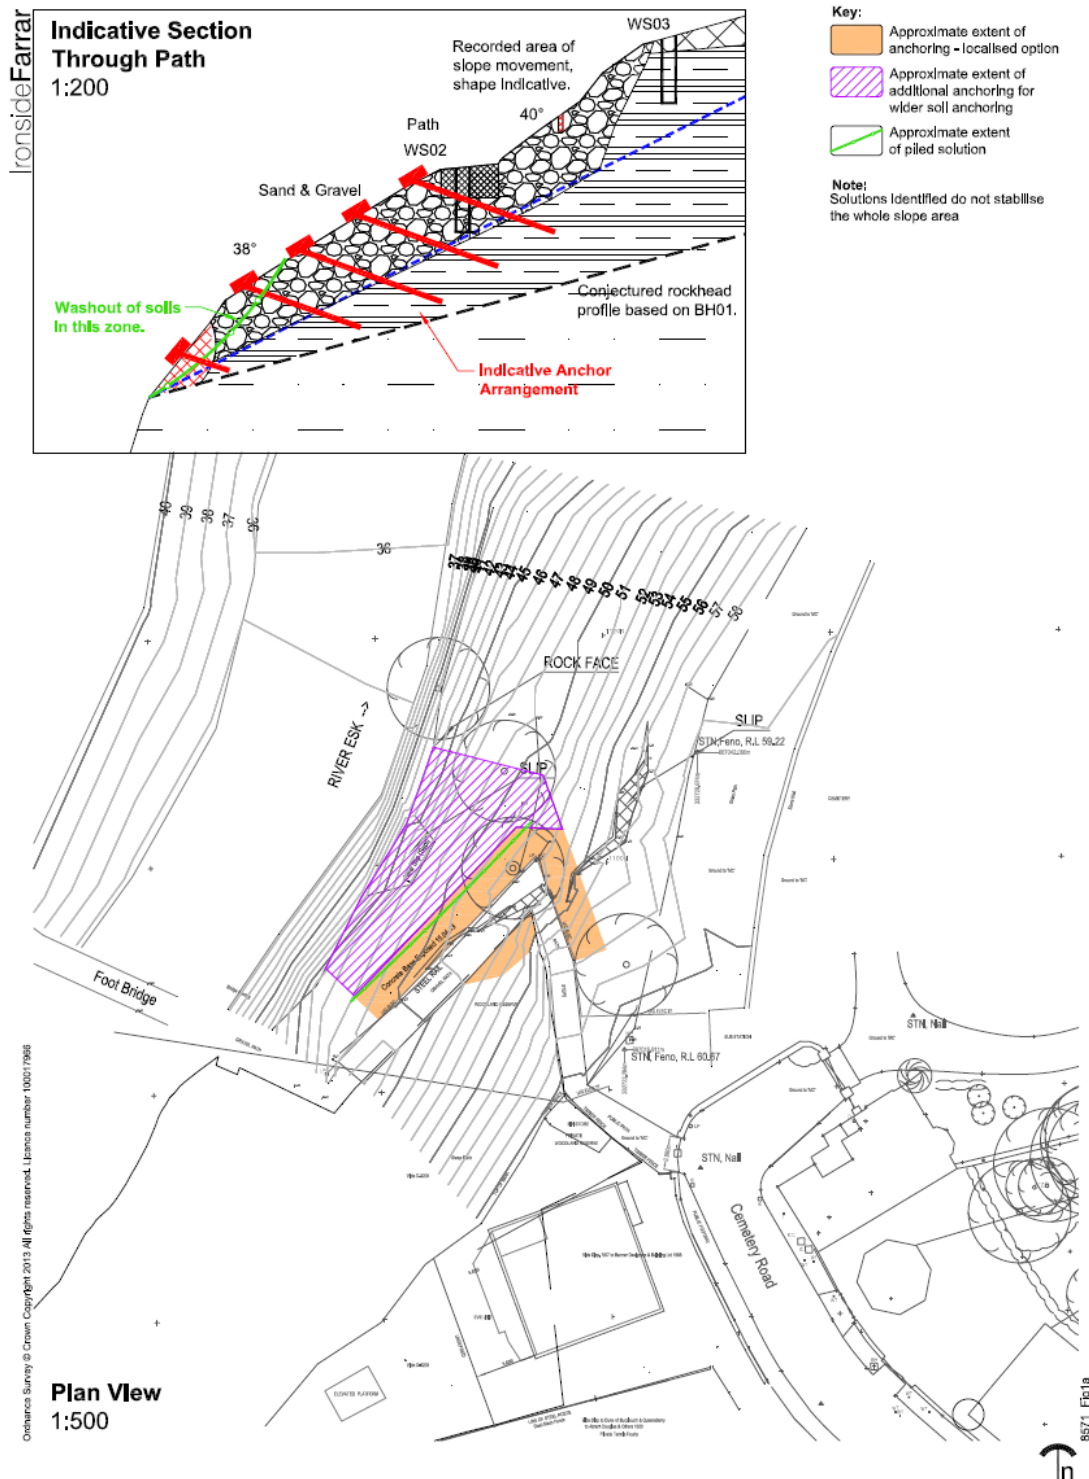
Figure 1
Potential Remediation Options

Detailed design would be required to confirm the configuration and spacing of any scheme. An outline scheme to stabilise the worst impacted area of an approximate 23m length of path by driving anchors in a grid to 3m below the path plus an additional area of 10m by 3m around the dog leg has been costed, with a sketch design provided on Figure 1:

Approximate area of Stabilisation = $23\text{m} \times 3\text{m} + 10\text{m} \times 3\text{m} = 99\text{m}^2$, say 100m^2

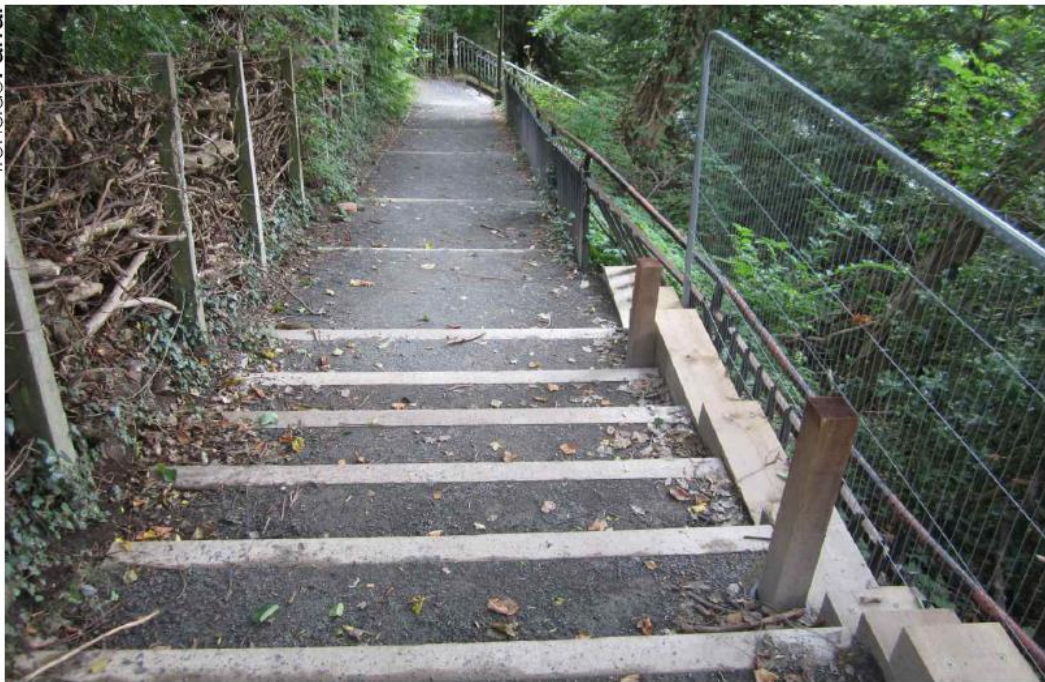
Photo 1. Repairs to steps below "dog-leg" section.

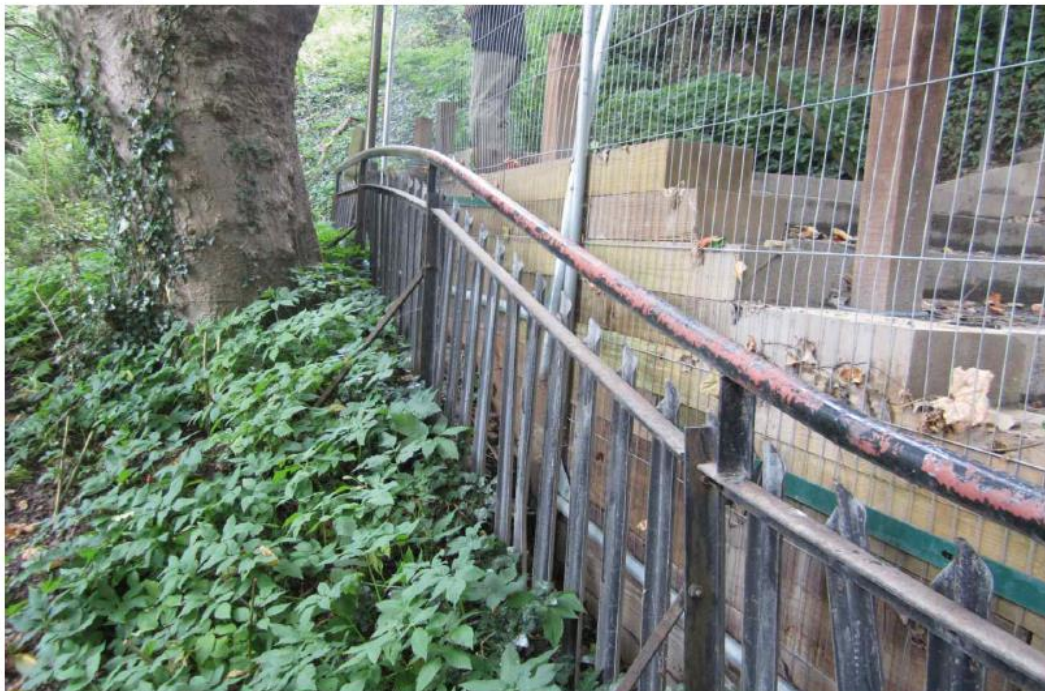
No obvious sign of movement to the large sycamore tree immediately on the downhill side of the main dog leg on the steps was noted.

Photo 2. New timber edging and Sycamore tree at "dog-leg" insteps.

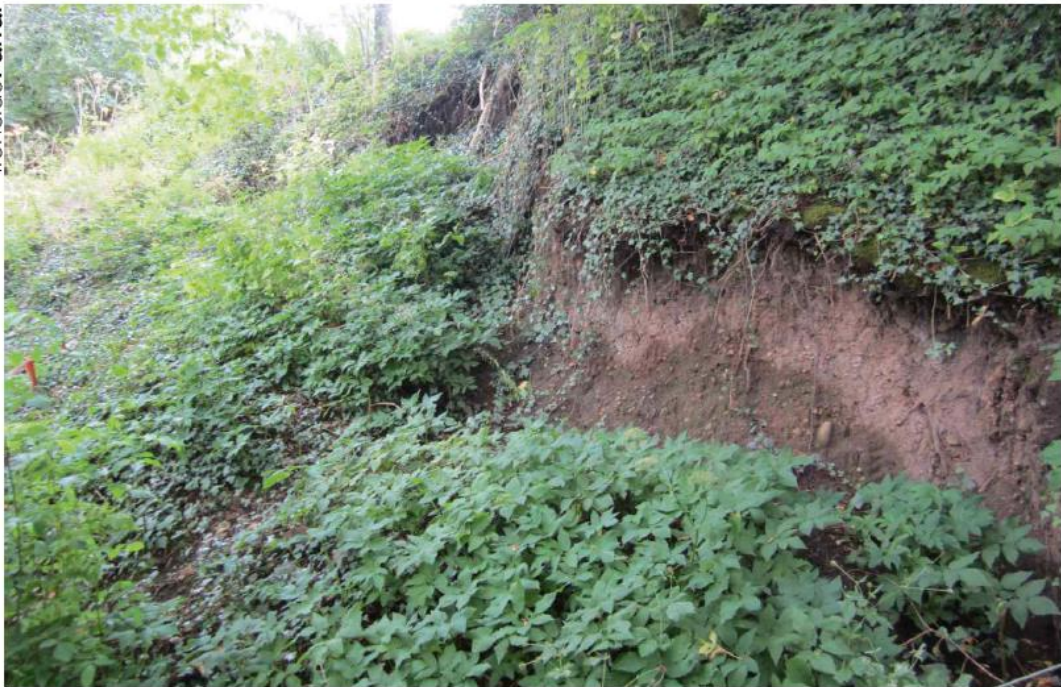
No other areas of significant movement were readily apparent on the site walkover. Previous areas of slippage were still evident but did not appear to have deteriorated.

Photo 3. Section of slippage prior to December 2014, no deterioration noted.

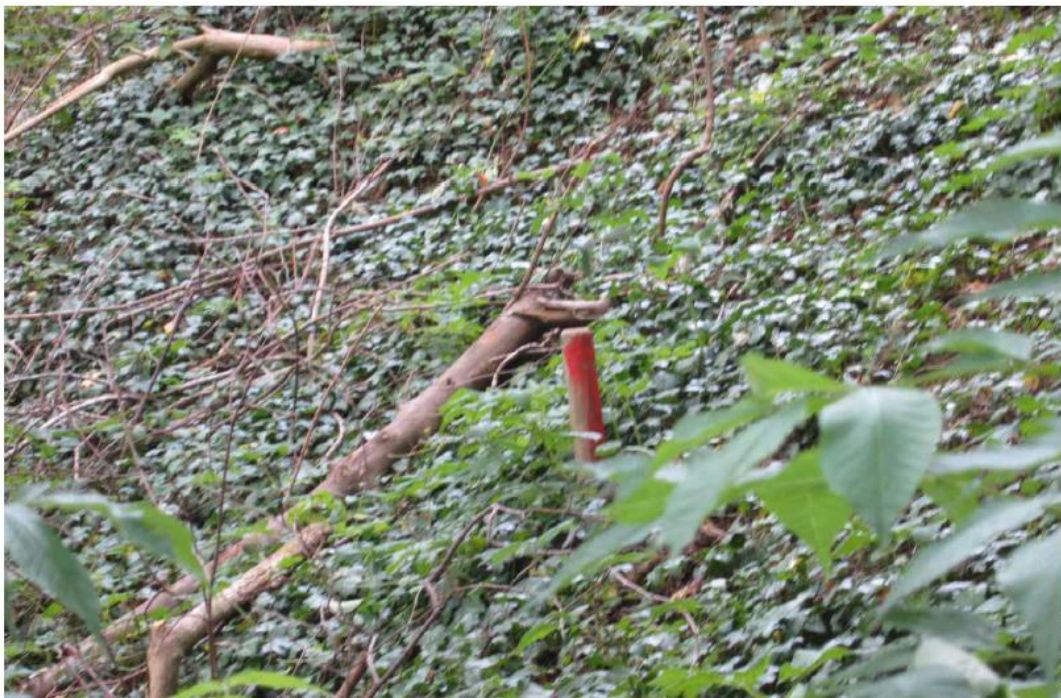
A brief check with a pocket spirit level of the two marker posts installed at the furthest points from the path, some 30m north of the point of the dog leg identified that they were some 30mm and 40mm out of plumb on the above ground sections tilting downslope. The posts were installed vertically suggesting a degree of movement. Note that this movement had occurred at some stage since March 2014 when the pegs were installed and not necessarily post the remedial works, as the recorded monitoring by MC makes no specific reference to the observations noted above.

Photo 4. Marker post out of plumb.

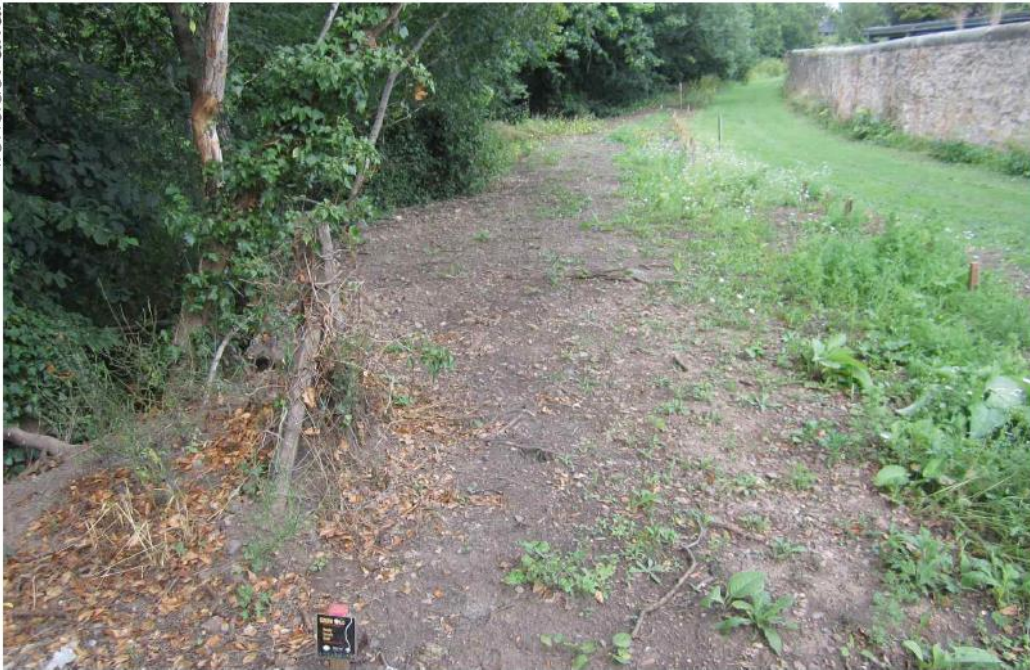
Photo 5. Disturbed ground associated with new cut off drain at top of slope.

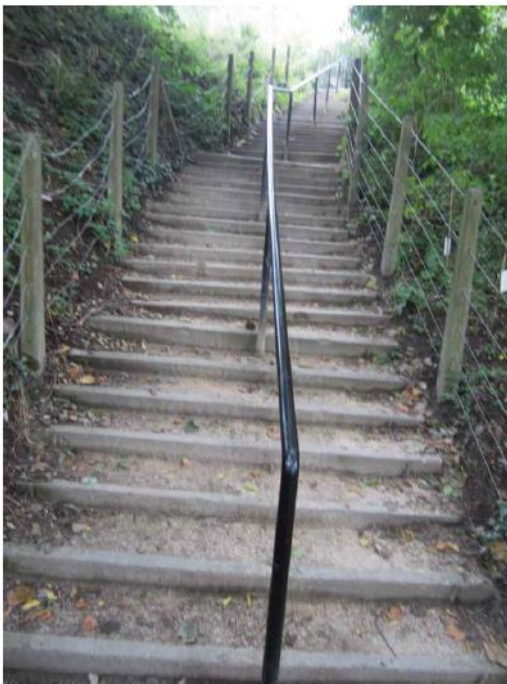
Photo 6. Upper section of steps.

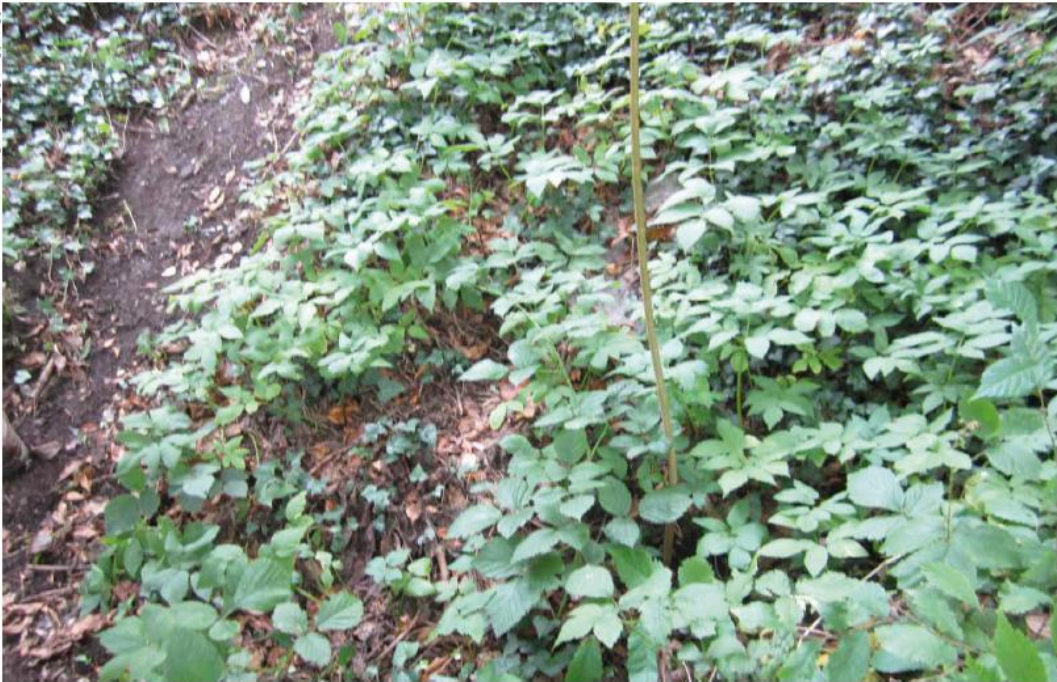
Extensive willow planting has been undertaken to the banks with whips. The vegetation was not noticeably established as would be anticipated given the short period since planting. MC noted that it appeared that a number of the plants look like they may not have taken although the full extent was not reviewed at the time of the walkover.

Photo 7. New willow plant-whip.

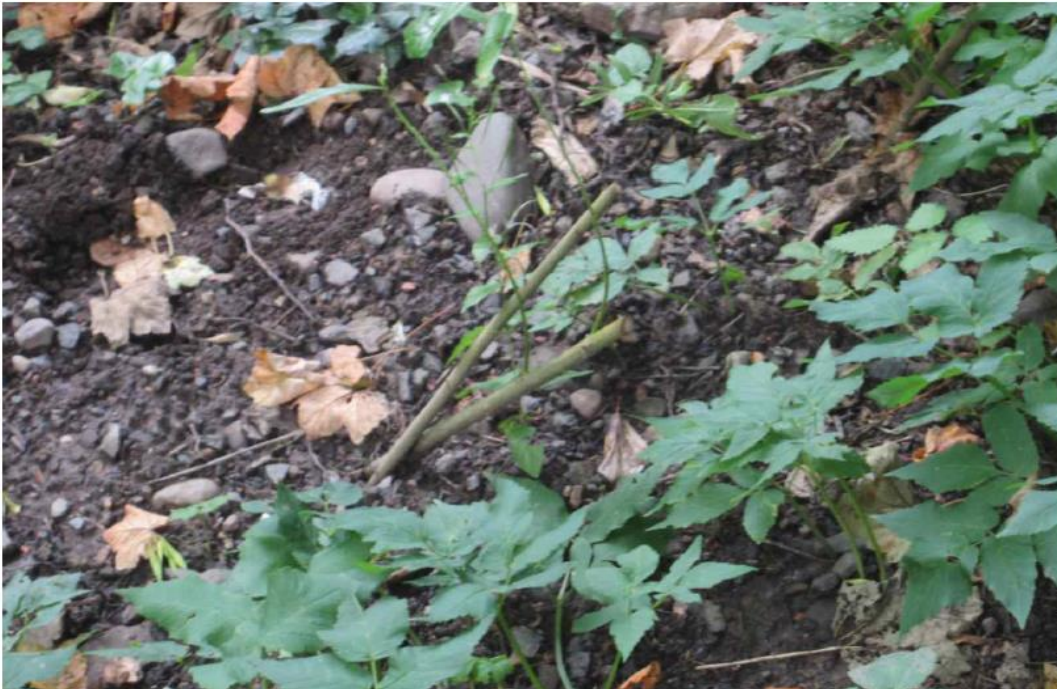
Photo 8. New planting.

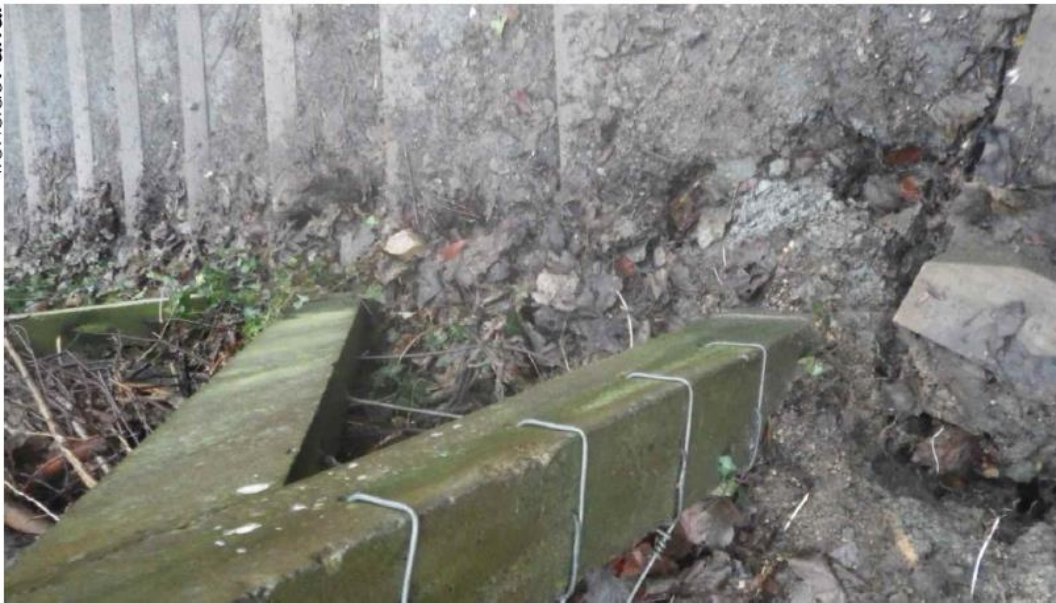
A crack of some 50-100mm was visible along the top edge of the return leg of the steps. This extended through the lower step itself of the bottom step before the return leg.

Photo 9. View at corner of steps

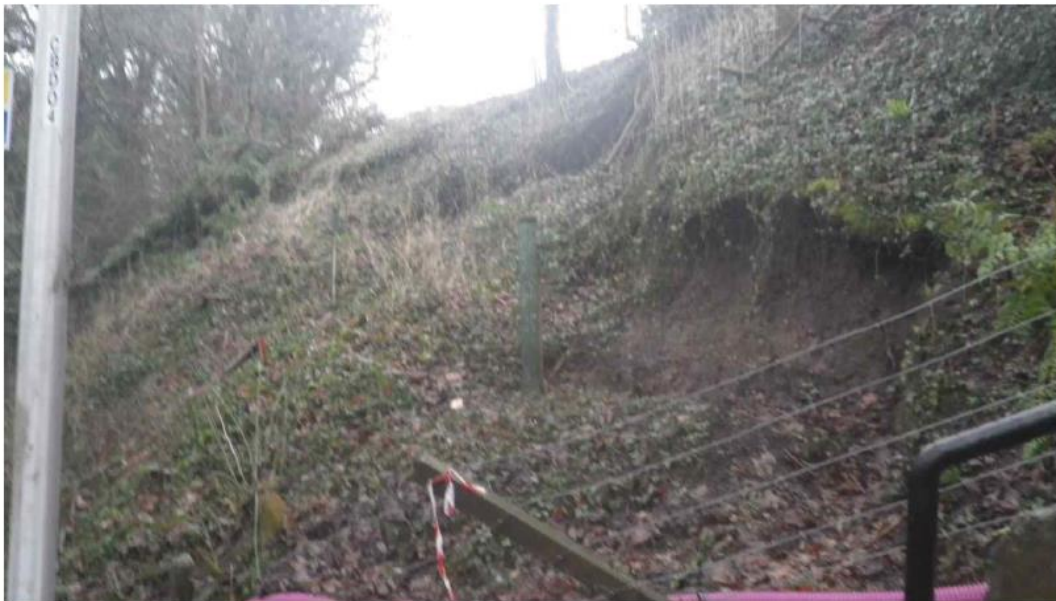
Movement in the earth below and parallel to the return leg of the steps had also occurred with cracking apparent. MC noted that there had been noticeable movement since their visit of the previous day.

Photo 10. Slope slipping

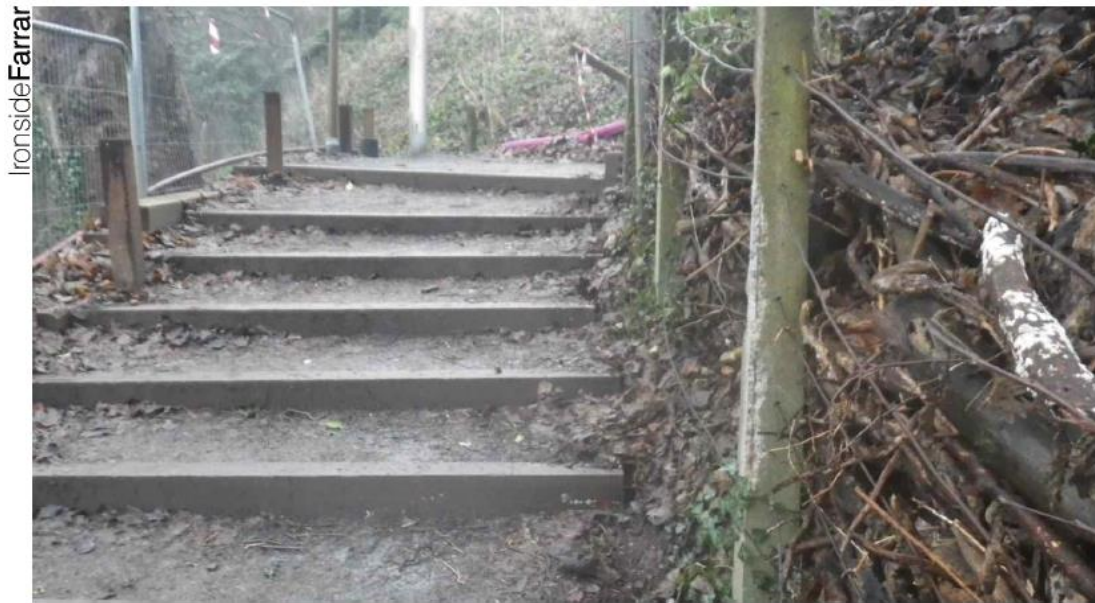
Photo 11. View up steps

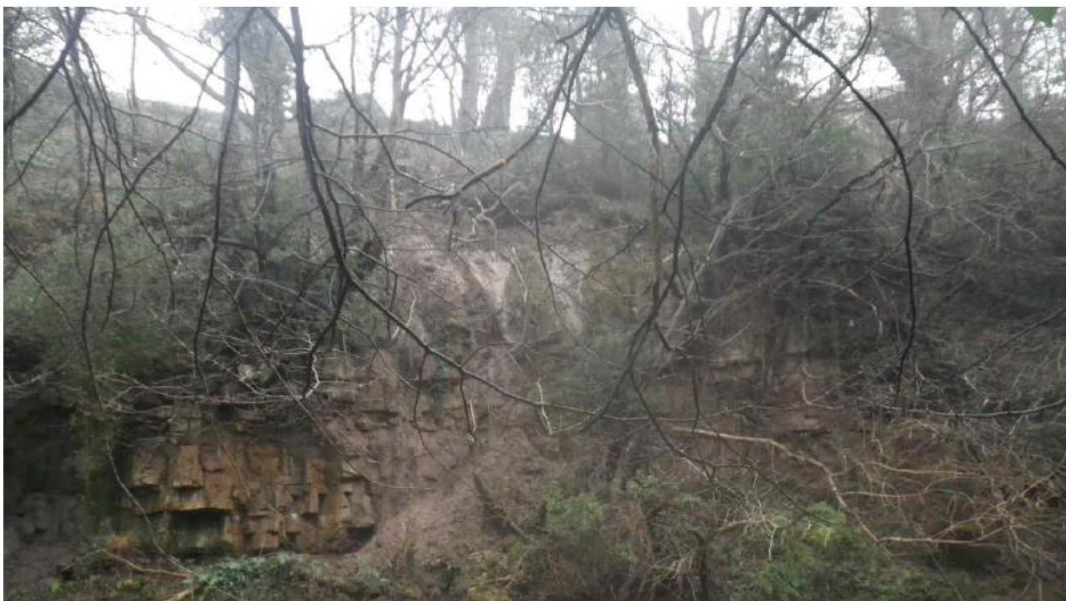
Again, this area was viewed from the opposite bank of the River Esk. Visible and significant deterioration was noted. This included washout of soils and water running over the face of the slope over significant extents. Sands and gravels washed out of the slope had formed a pile at the river's edge/ base of rock face.

Photo 12. Area of wash out above rock face

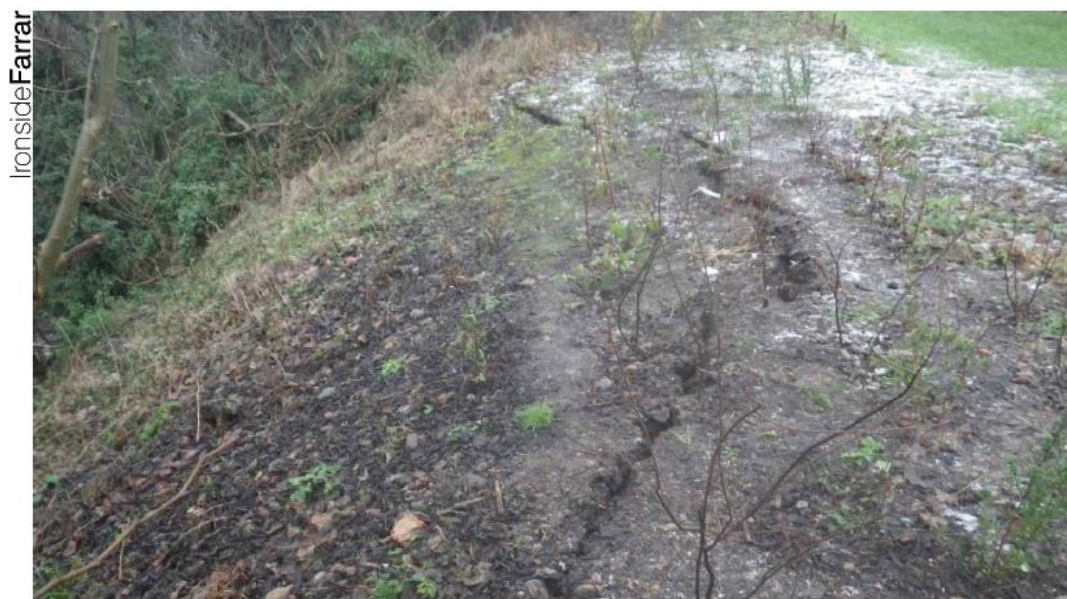
- Cracking and slumping of an area of the top of slope in the vicinity of the new planting.
- Extensions to previous cracks/ areas of visible slope failure.

Photo 13. Area of top of slope

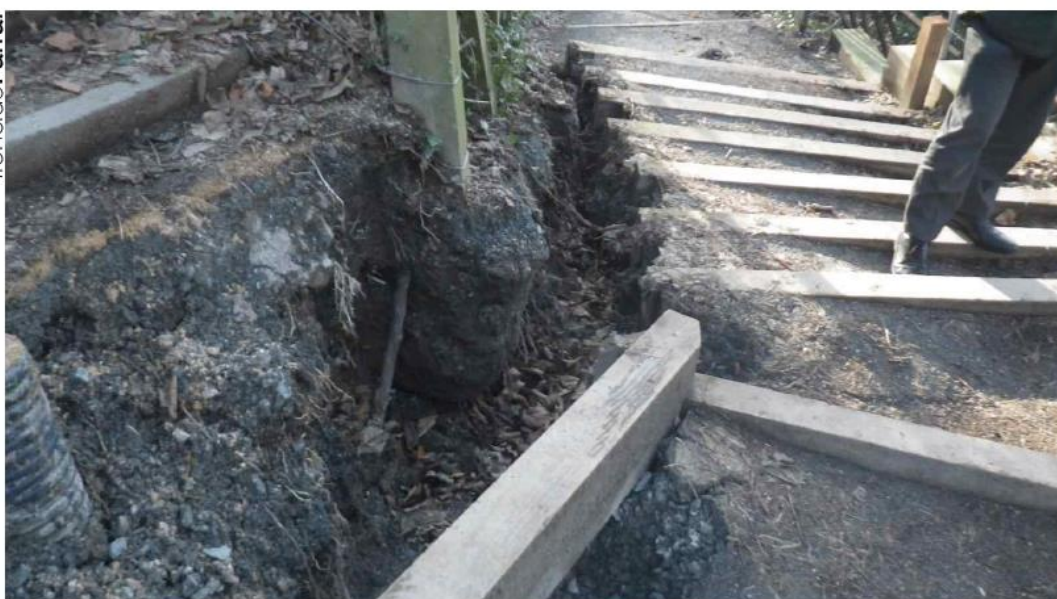
- Cracks of order 500mm to 600mm at top edge of step.
- Dropping of sleepers on down slope side of path by up to 500mm.
- A number of strainers in the post and rail fence were tight due to the slope movement.
- Cracking in soils below the steps.
- Saturated clays noted near the surface in the small void under the steps. The void was held up by sleepers/ concrete edging.

Photo 14. View down steps

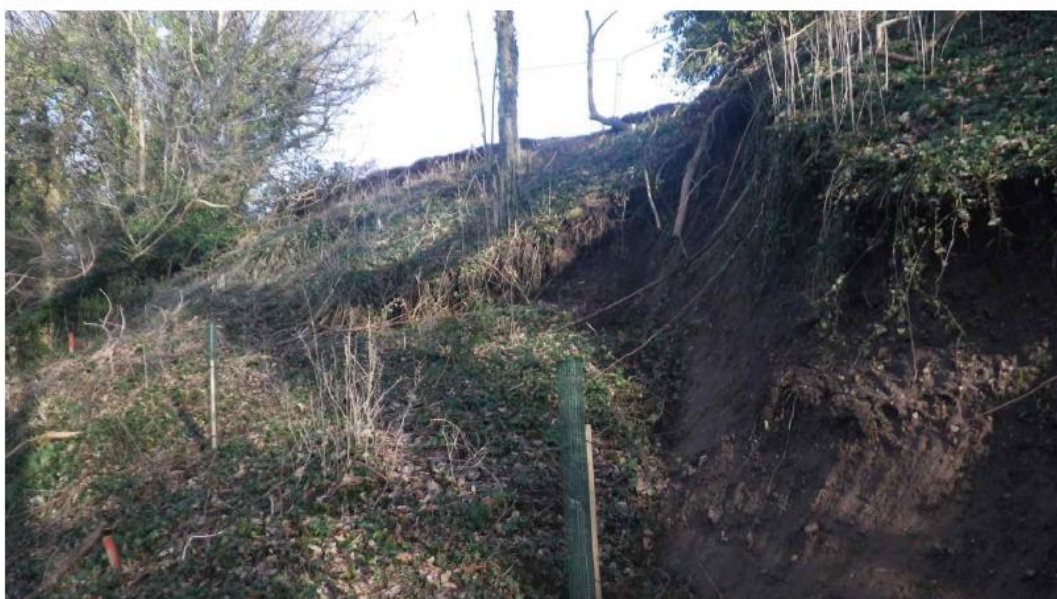
Photo 15. Slope slipping

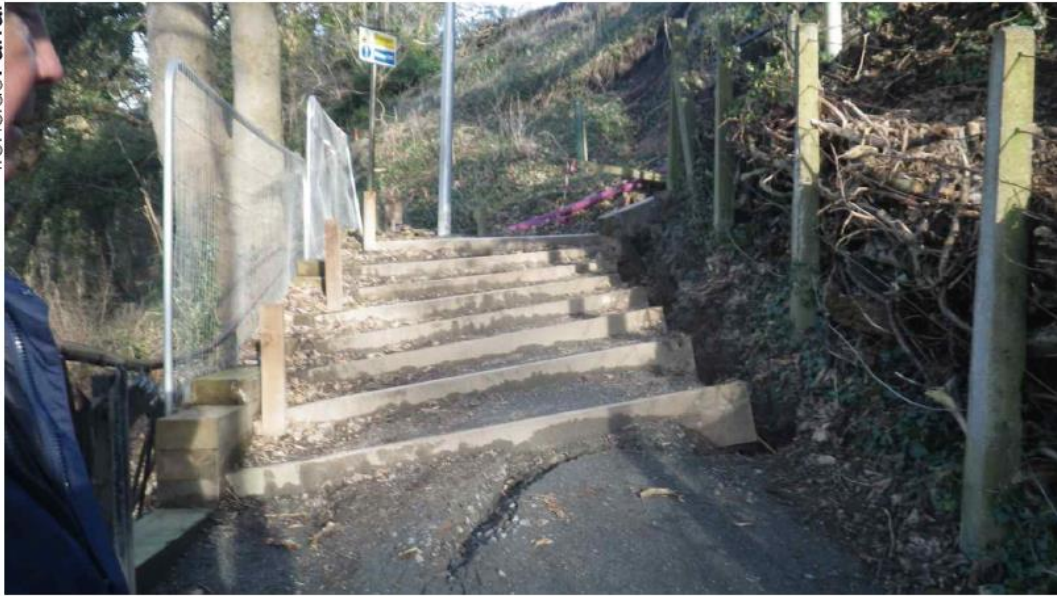
Photo 16. View up slope

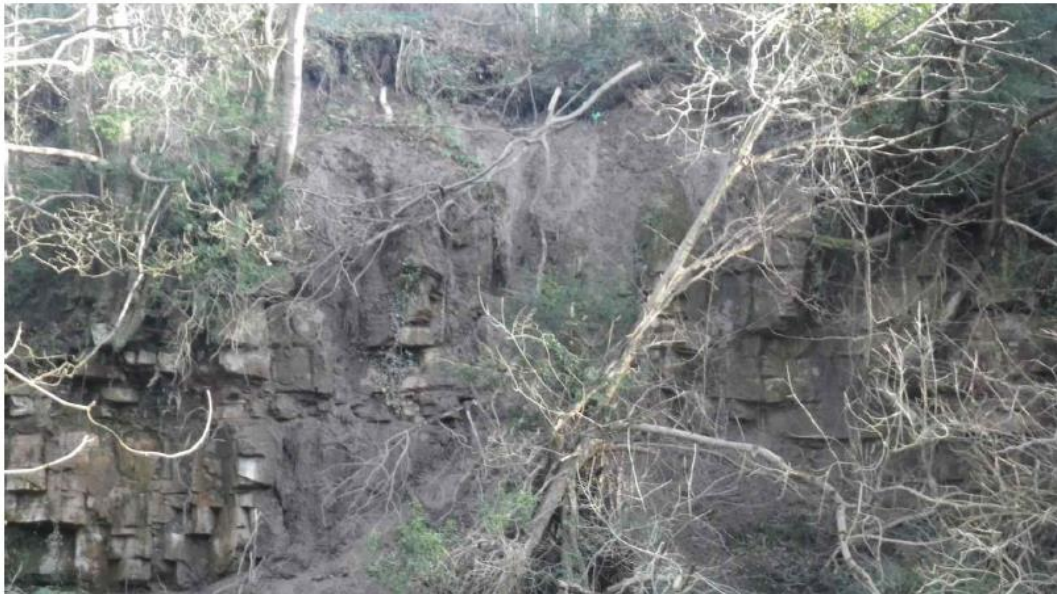
- Ongoing of washout of soils noted with significant deposits at the base of the cliff face, some movement noted at time of walkover. Soils appeared completely saturated.
- Lateral cracks appearing above the area of washout.
- Lateral extent of washout widened along cliff face.

Photo 17. Area of wash out above rock face

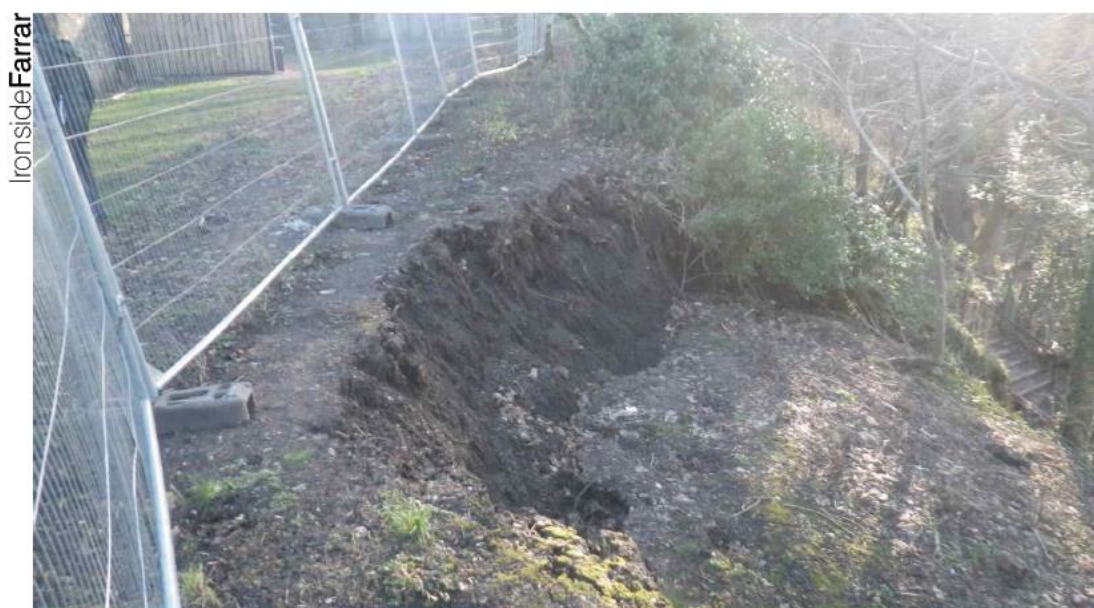
Photo 18. Area at top of slope

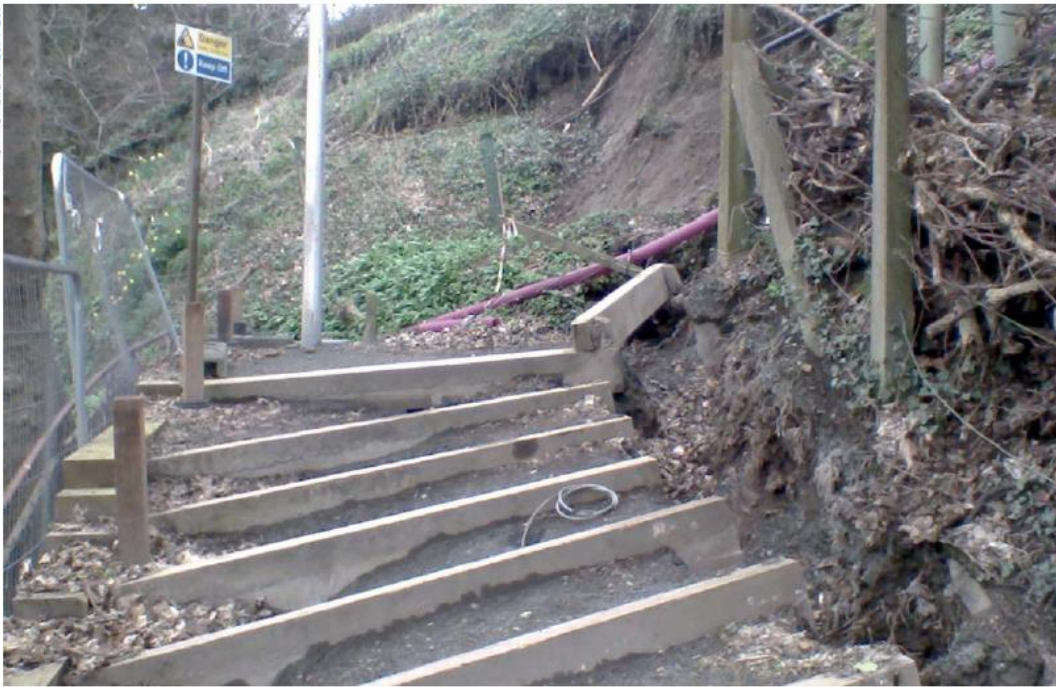
- A drop of several feet of the path, with maximum movement noted at the dog leg/ corner.
- Significant loss of vegetation, soils and cutting back of the slope below the path.
- Significant slumping of soils from the crown of the slope in front of the cemetery.
- Significant built up of soils and vegetation below the rock face, on the riverbank.

Photo 19. View at Corner of steps (16.04.16).

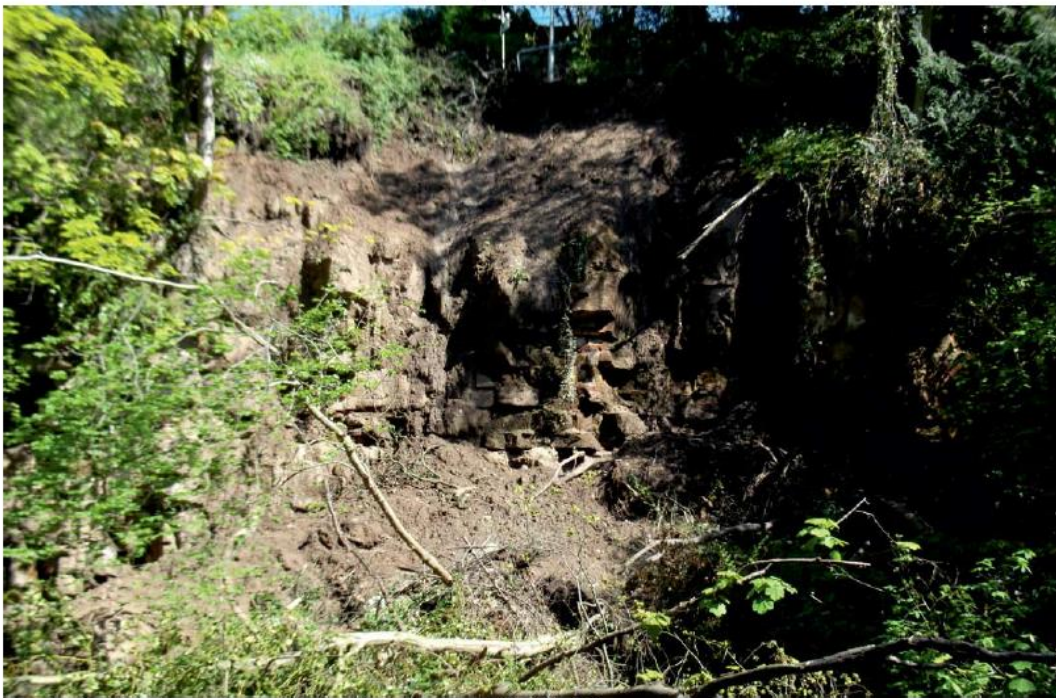
Photo 20. Washout at rock face / lower slope (23.04.16).
