Structural Report - Mayfield Primary School and St Luke's Primary School**Report by: Kevin Anderson, Executive Director - Place****Report for Decision****1 Recommendations**

Mayfield and St Luke's Primary schools are scheduled to be replaced within the next 24-30 months and the conclusions and recommendations drawn reflect this limited residual life. This report seeks to summarise the findings of a non- intrusive visual condition survey into structural elements of Mayfield Primary School and St Luke's Primary School following an incident of falling masonry, and set out actions taken to make the building safe as possible for its remaining expected life span.

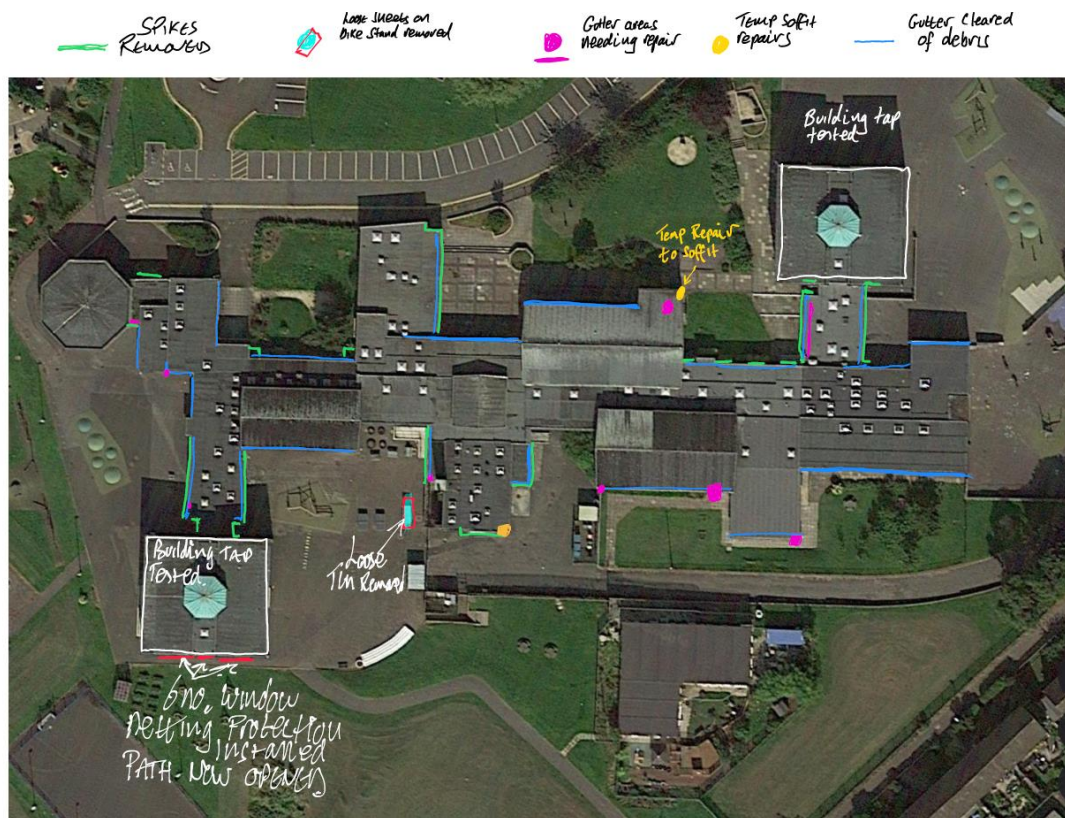
**Appendix B –
Aerial Photograph summarising locations of works carried out during survey**

3.6 Contingent with the survey, a construction team were engaged and worked under the direction of the engineers to undertake necessary remedial measures. This included tap testing the structural concrete areas of the two tower structures (and removal of loose or unstable materials), clearing out and repairing gutters and soffits, removing historic anti climb spikes.

3.7 Loose glass fragments were removed from glass blocks and sharp edges made safe on the outer side only as inner side not broken and adhesive film

applied to the outer surface. In addition window netting protection was installed on 6 windows on the St Luke's PS tower allowing a previously closed pathway (for safety reasons) to be reopened. See Appendix B1 for a summary photograph of treated areas and a summary of the daily actions undertaken by the survey/contract teams during the period of the survey.

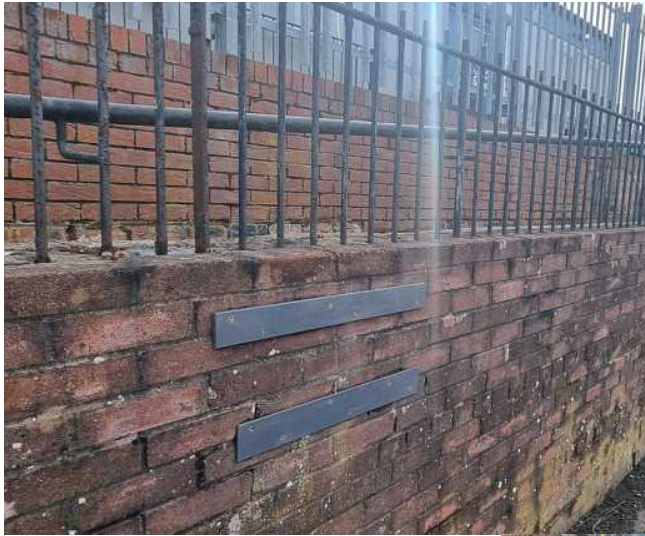
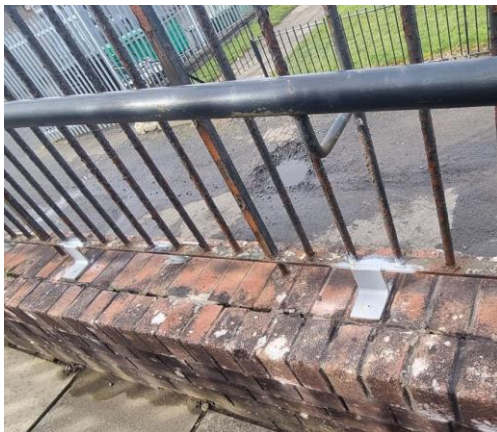
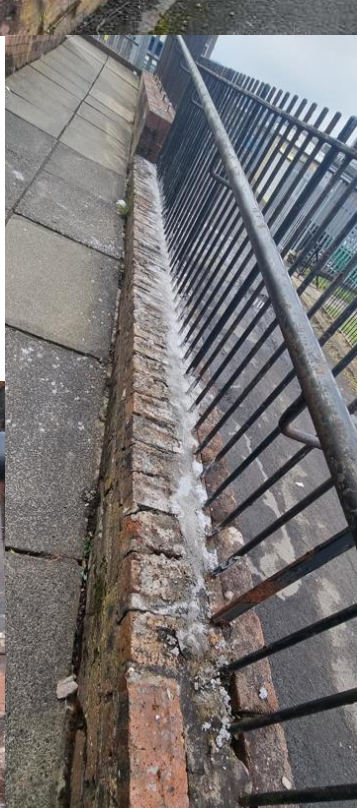
Appendix B2

Remedial works undertaken by Building Maintenance Services in conjunction with

Halston Engineering to address the loose wall-head, cracking in the retaining wall and loose railings identified during the structural survey.

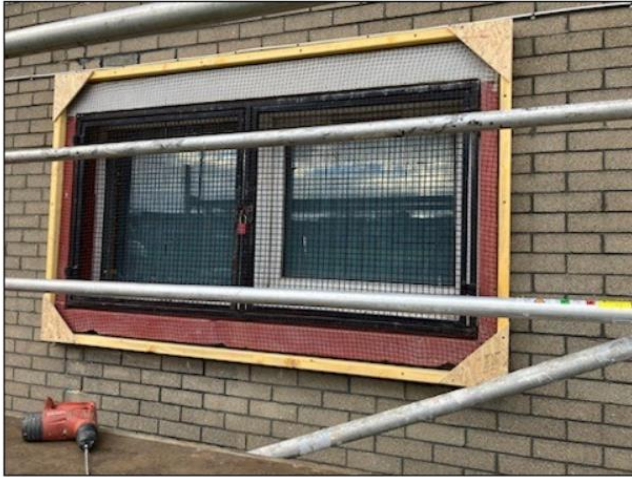
Appendix C –

example of protective netting

Similarly the protective Heras fencing which provides an exclusion zone around the building should remain in place and as positioned. This will be monitored on a regular to ensure this remains the case. At present this is impacting on the usable area of playground. Engineers have advised that a medium term solution to be considered which may allow removal of some of this fencing would be to install protective netting around the windows in these areas as has been installed at St Luke's PS (See Appendix C). This would require additional budget but would return play space to the school.

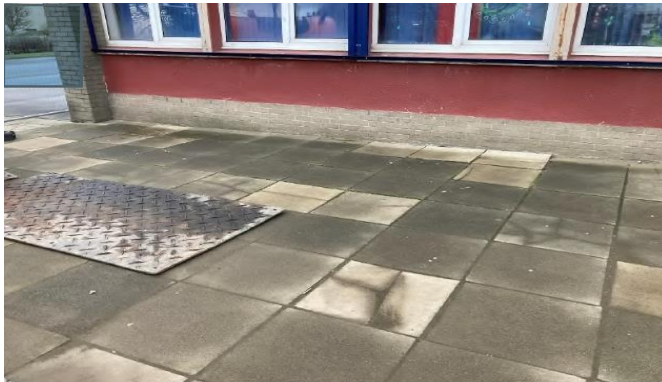
Slabbed playground area

- 3.10** One area that is of concern is the uneven slabs in the playground area which represent a trip hazard. This is an area of 2541 square meters. It is recommended that in relation to the remaining expected lifespan of the current school, repair or rebidding works are undertaken in order to address the trip hazards.
