## **ROSLIN CONSERVATION AREA CHARACTER APPRAISAL AND MANAGEMENT PLAN**

Conservation Area Character  
Appraisal & Management Plan

MIDLOTHIAN COUNCIL  
JUNE 2021 (As proposed for adoption)

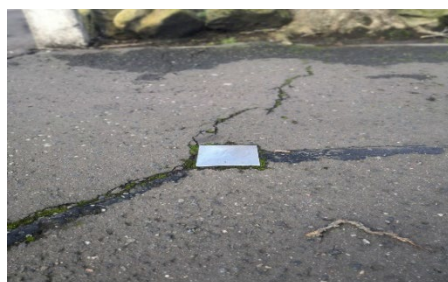
Metal stud showing location of market cross

9. In 1456 King James II granted Roslin a charter making it a Burgh of Barony with the right to a market cross, a weekly market and an annual fair. The foundations of the cross are buried under the crossroads of Main Street, Manse Road, Penicuik Road and Chapel Loan, and metal studs in the pavement near the Original Rosslyn Hotel mark its location.

38. The most notable public realm feature of the Conservation Area is the open space that used to be the former village green. There are also the metal studs in the pavement near the original Rosslyn Hotel marking the location of the village market cross. Other than these the existing public realm has no particular historic significance or character. Any future changes will need to respect and enhance the character of the Conservation Area. The same applies to signage and display boards.

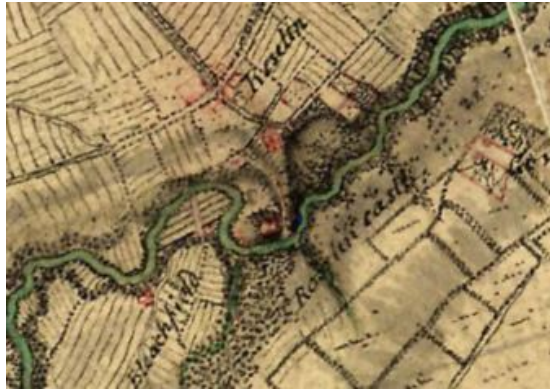
*Extract from Roy Lowland Map 1752-55*

10. The village in its current form grew in the 1800s as a mining village, although little of the village is included in the Conservation Area. The crossroads at the centre of the original village are included in the Conservation Area, and can be seen on the Roy Lowland Map of 1752-55 surrounded by a few buildings.

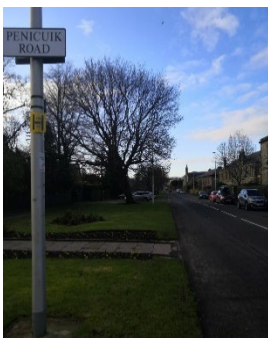
*Penicuik Road*

18. The built form of the village character area developed around the crossroads which form the junction of Chapel Loan, Manse Road, Main Street and Penicuik Road. The architecture is mainly Victorian built of sandstone and slate, comprising larger buildings on the north-eastern and north-western corners (both hotels) and residential scale buildings. The residential properties on the northern side of Penicuik Road are set closer to the road, with small front gardens and comprise terraced or semi-detached properties. On the south side of Penicuik Road and Manse Road, the properties are set back from the street. There is a grassed area separating the properties from Penicuik Road, which was formerly the village green. The village war memorial is located in this greenspace, close to the crossroads. The properties on the southern side of Penicuik Road are mainly Victorian detached villas with large front and rear gardens, complemented by some infill development from the early 1900s and a modern villa at the corner with Chapel Loan.

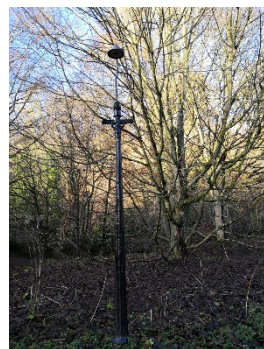
Area downriver of the bleachfields/carpet factory site has remained undeveloped except for the two castles.

Industrial Remains at Carpet Factory site

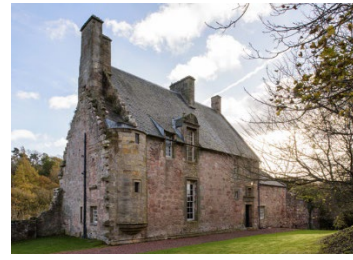
*Roslin Castle*

22. Roslin Castle is built of squared, coursed pink sandstone rubble. There are slate and lead roofs and mainly sash, or fixed windows, some with astragals. Rosslyn Chapel is built of ashlar sandstone (cream and grey) with deeply carved sandstone dressings. Windows are stained glass and leaded. The roof is barrel vaulted. Hawthornden Castle is built of pink sandstone rubble with ashlar dressings. It has a slate roof and cast iron rainwater goods. The glazing patterns are of various dates, including some from 18<sup>th</sup> century with thick astragals, and a row of 19<sup>th</sup> century dormers. The windows are mostly 12 pane timber sash and case, with some nine and four pane also. College Hill House was built in 1660, with alterations taking place in the 1760s and early 1800s. It was fully refurbished in 2002. Its walls are dressed sandstone blocks, now covered with harl and lime wash. The roof is pantile, with slate run-off.

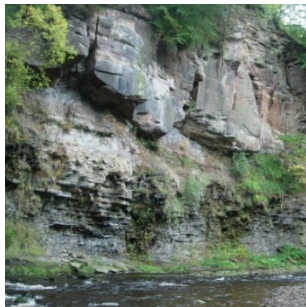
23. The landscape setting for this Conservation Area is dictated by the deeply incised wooded gorge of the River North Esk. The gorge supports a mixed deciduous wood with ground flora characteristic of ancient woodland. Roslin Castle, Rosslyn Chapel, Hawthornden Castle and the village of Roslin sit on elevated ground above this glen. Much of the Conservation Area lies within the Glen, which is a nationally designated historic designed landscape, a Site of Special Scientific Interest (SSSI) and a Country Park. The Glen also sits within the locally designated North Esk Valley Special Landscape Area and contains designated Local Biodiversity Sites and a Scottish Wildlife Trust Reserve.

*Steep rocky side of Glen*
