## **GOREBRIDGE CONSERVATION AREA CHARACTER APPRAISAL AND MANAGEMENT PLAN**

# Gorebridge

Conservation Area Character  
Appraisal & Management Plan

**Draft for Consultation**  
**August 2019**

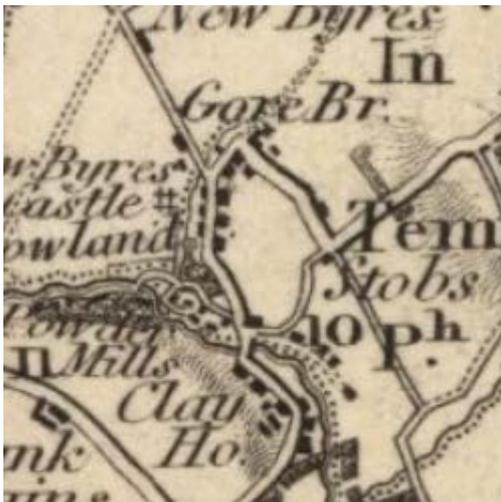
Sharp, Greenwood & Fowler Map of the County of Edinburgh (1828)

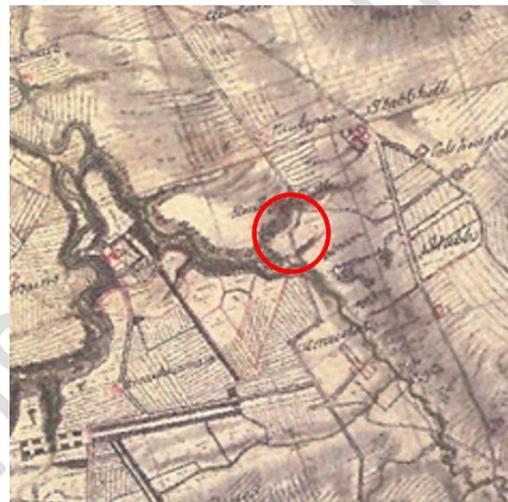
Roy Lowland Map (1752-55)

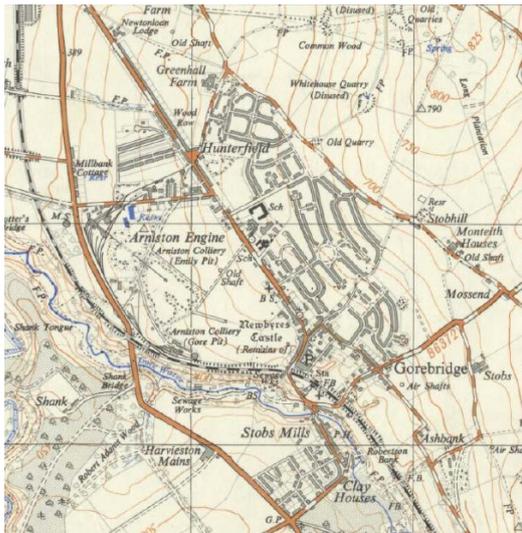
Ordnance Survey 1955

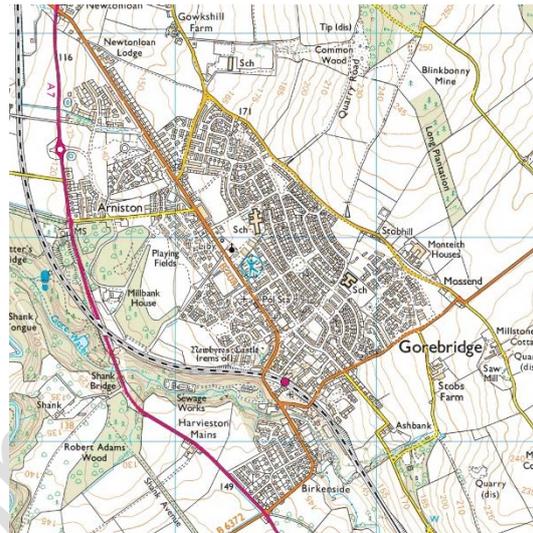
Current Ordnance Survey

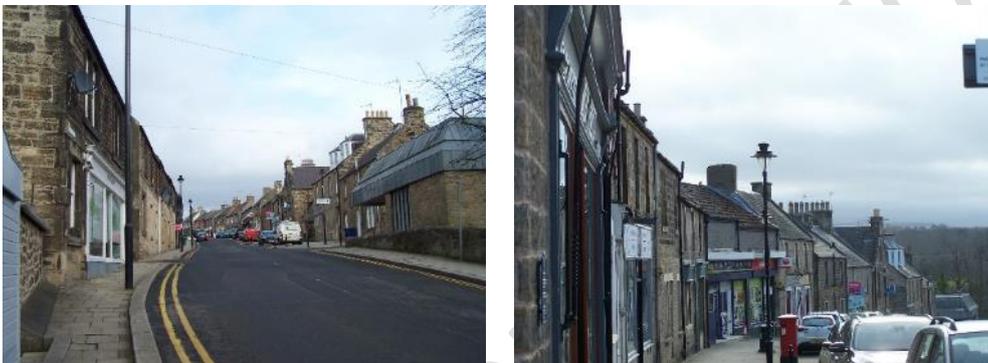
10. The streetscape along Main Street is defined by its two opposing rows of buildings fronting directly on to the street. The road runs down the steep hill to the valley, and corresponding to this the roof ridges reflect the fall in the street. The result of the strict formation of buildings is that when approaching from the north and looking down towards the valley, attention is drawn through the narrow corridor formed by the buildings out to a glimpse of the horizon, which opens out into panoramic view of the hills beyond when travelling down the street. The skyline in this lower section of the Conservation Area is characterised by diminishing or rising building heights (depending on direction faced) and a regular pattern of chimney stacks.

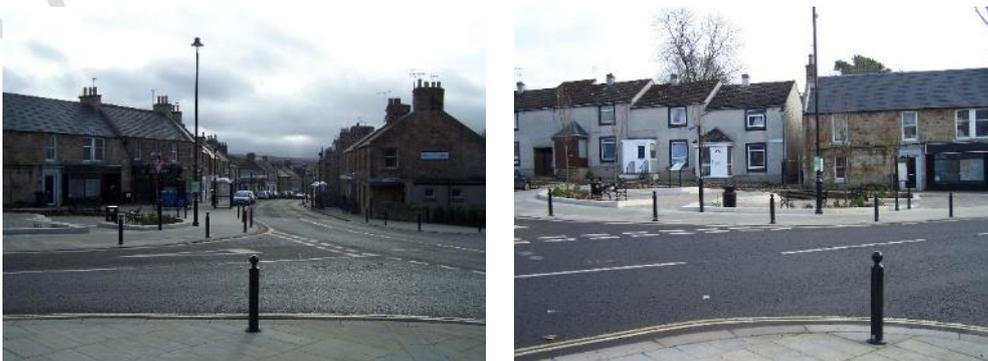
11. At the northern end of Main Street, the streetscape opens out into Hunter Square and Hunterfield Road. The looser knit and wider street scene of Hunterfield Road, with its properties set back from the street, contrasts with the character of Main Street. The original street layout at the junction of Hunterfield Road and Main Street had a narrower carriageway, but buildings were demolished to widen the street. This area has been improved recently to create a functional civic space for the community. Beyond this, on Hunterfield Road, there are coal mining cottages with their distinct steeply pitched rooflines and regularly positioned chimney stacks. Rubble sandstone walls and well maintained hedges line the street and, in contrast with Main Street, the buildings are set back from the street to provide an element of privacy. From this point on the hill there are panoramic views to the south out above the roofline of Main Street.

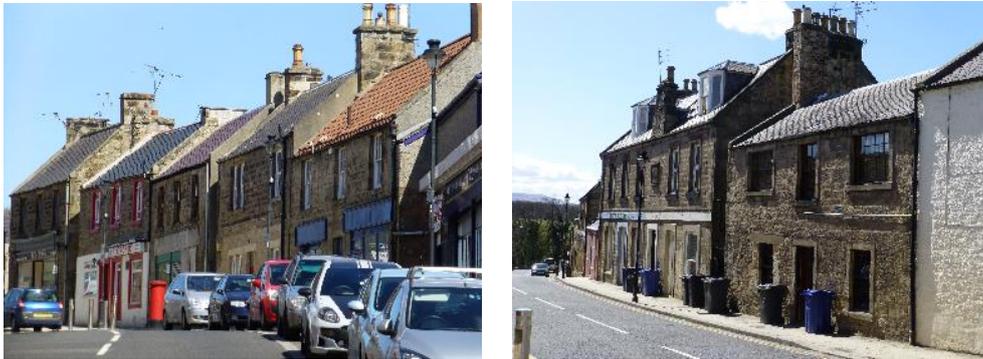
12. The Conservation Area has two distinct architectural styles, with the exception of the ecclesiastical and modern buildings.

The first style is along Main Street, where the buildings are predominantly rectangular plan, 2 storey terraced houses, built for commercial use and fronting directly onto the street. The buildings form a distinct linear street plan. Most of these buildings have plain facades featuring large windows or shop fronts on the ground floor and residential premises above. The main change to this pattern over the years has been the conversion of ground floor shops to residential premises. Rooflines on Main Street are generally aligned parallel to the carriageway with occasional gable ends at right angles to the road, for example the Old Post Office, which has a baronial style crow stepped gable.

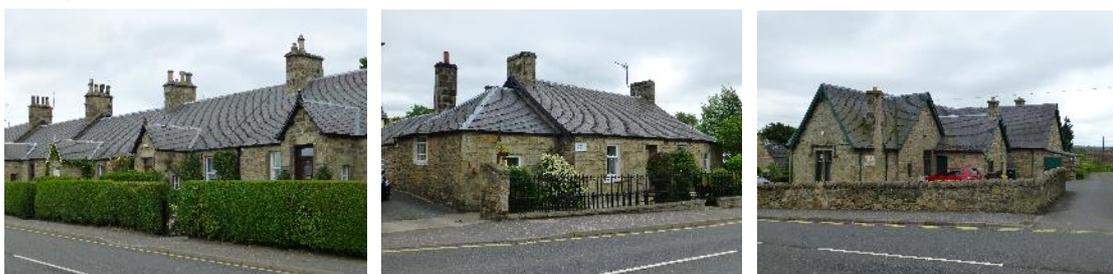
The second style is found on Hunterfield Road, and is defined by cottages with steep pitched roofs, bargeboards, finiaed porches, and in some cases further detailing such as hood moulded windows and heraldry.

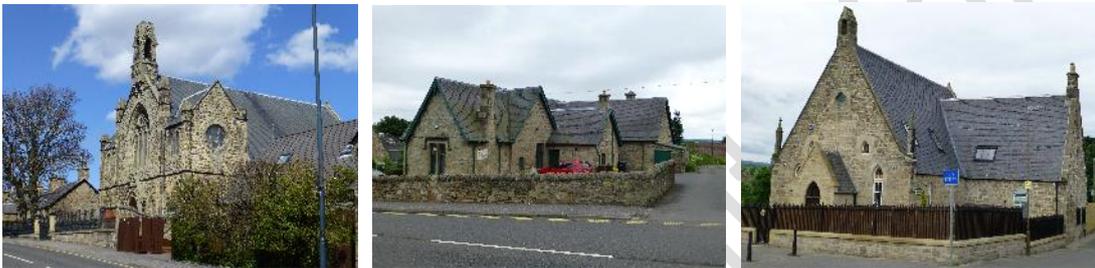
13. There are a few notable exceptions to the styles identified above. These include 13 Hunterfield Road, which is a Category C listed building built in 1886 as a public library (Newbyres Reading Room). It is a single storey, 3 bay, Tudor gothic style building of tooled squared and snecked sandstone with overhanging eaves. It has 2 pane and 4 pane timber sash and case windows, a grey slate roof with lead ridge, cast iron rainwater goods and wallhead stacks. The Category B listed former church at 20 Hunterfield Road, which is now a children's nursery, was built in 1886. It is a gothic revival church with truncated bellcote (originally a spire) with sandstone walls and a slate roof. Newbyres Hall (5 Hunterfield Road) was built as a Free Church in 1858, then turned into a village hall in 1882. It was restored as part of the Conservation Area Regeneration Scheme, and now accommodates a children's nursery.

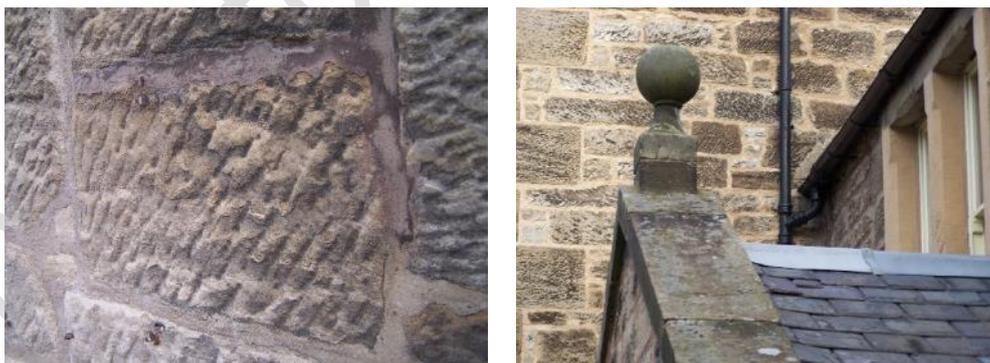
14. The buildings in the Conservation Area are primarily of sandstone masonry construction on the street facing façades and a mixture of rubble and brick to the sides and rear. The masonry finishes on the principal façades are mainly roughly pointed ashlar, often speckled and with a form of tooling to the face. The buildings with finely jointed ashlar also have other more decorative and detailed finishes such as carved window and door surrounds, and carved panels, usually indicating greater wealth of the original owners.

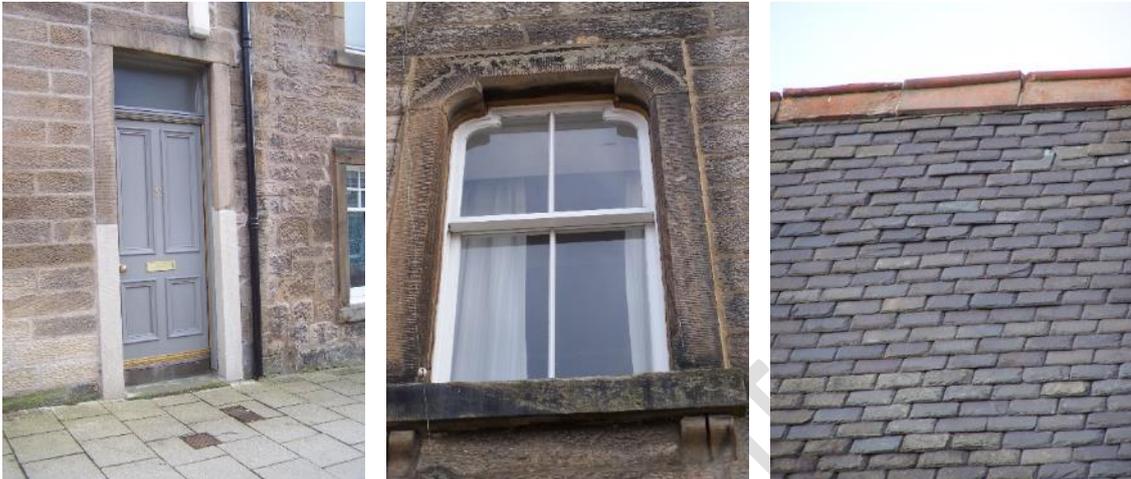
15. The majority of roofs in to conservation areas are finished in slate, with most appearing to be Welsh slate. Over the years a high proportion of the original windows and doors in the conservation area have been replaced, leading to a variety of styles, shapes, colours and material. Progress on restoring these has been made through the recent Conservation Area Regeneration Scheme.

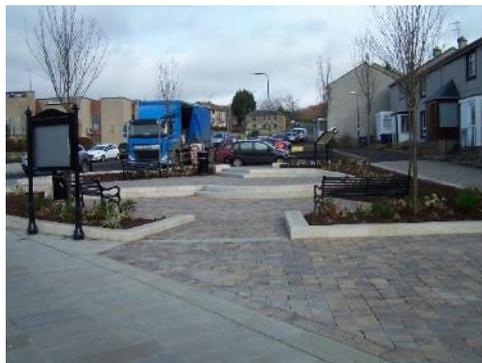
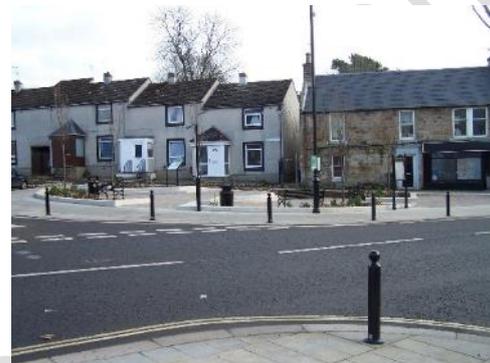
18. The public realm in the Conservation Area mainly consists of the footways between the road and building frontages. Along Main Street the footways are paved in light coloured stone slabs. The car parking bays along the eastern side of Main Street are defined by modern red and grey setts. The footways on Hunterfield Road are tarmac. The only area of civic open space in the conservation area is Hunters Square, which is paved in yorkstone with whinstone kerbing and granite block detailing.

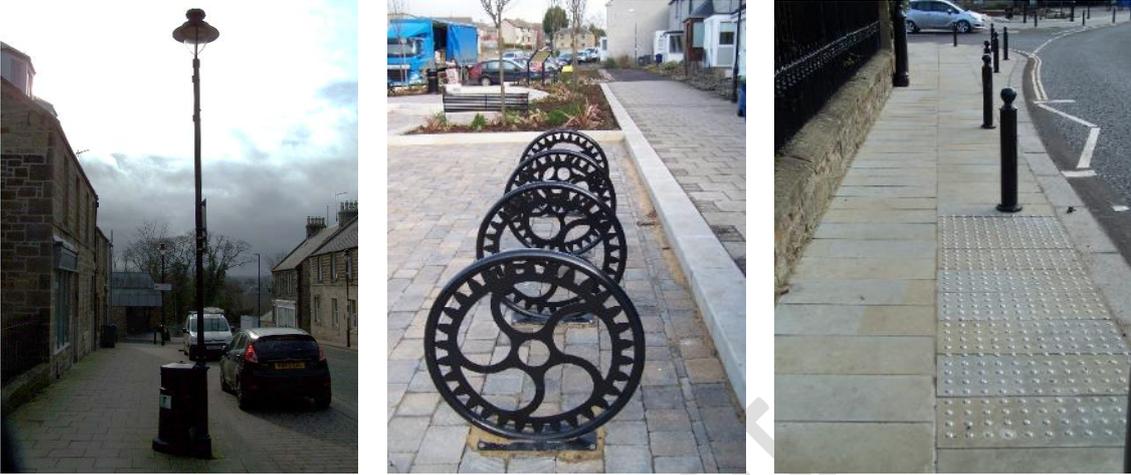
- 20. The street furniture in the Conservation Area is modern, but designed to be sympathetic to the setting. There are lamp posts, bollards, bins, bus stops, benches and a community noticeboard. There are also bespoke cycle racks in Hunter Square, designed to reflect the industrial heritage of the town. All are black painted metal.
